ENGINEERING ANALYSIS
OF THE
RUSSIAN T34/85 TANK

SEPTEMBER, 1951

CIA Information Report
Number 00-T-00061

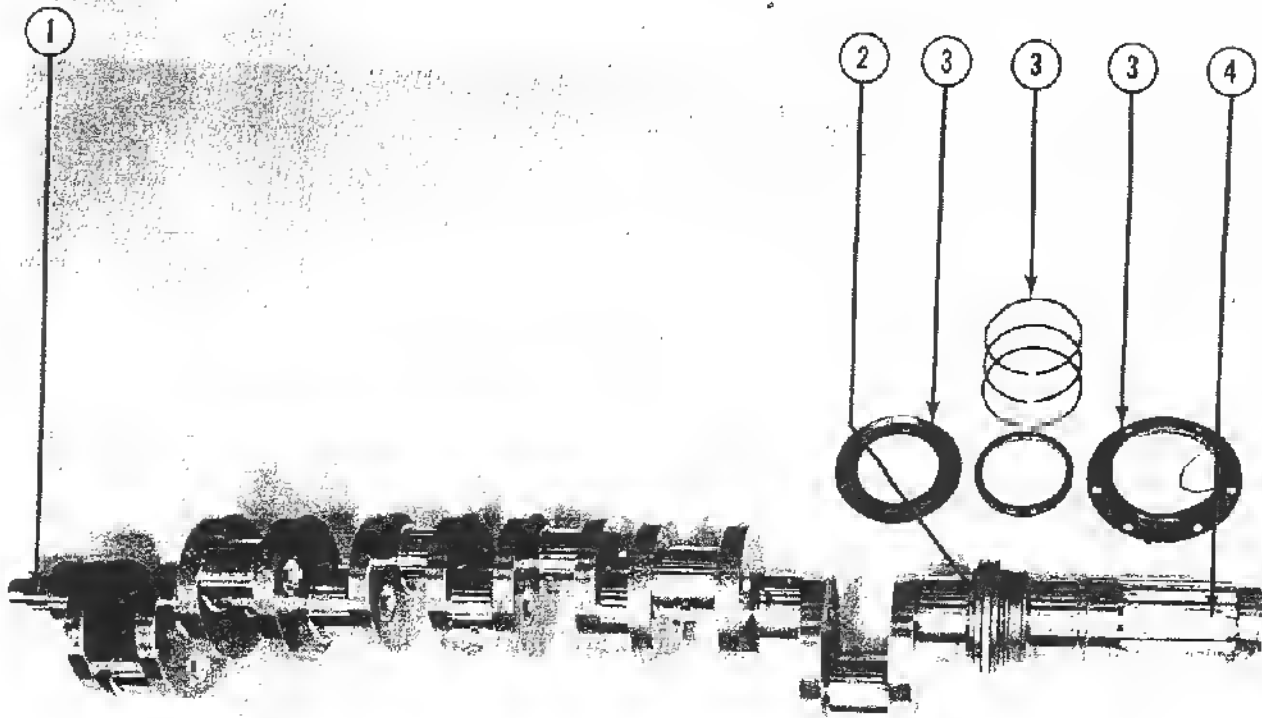
0102 - CRANKSHAFT - ENGINE

This crankshaft, machined all over, was found to have been forged rather than turned from a billet. Note the provision of the ball thrust bearing between the two rear main bearings. No difference was found between the two crankshafts from the two engines examined.

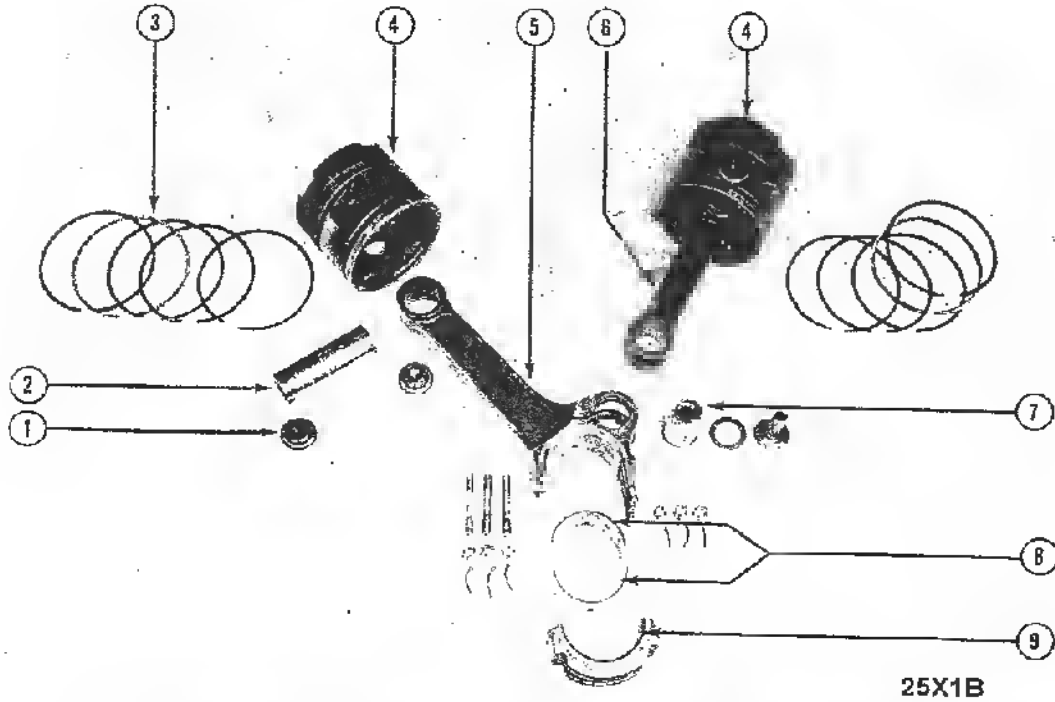
0104 - PISTON AND CONNECTING ROD ASSEMBLY - ENGINE

All parts in the assembly were well made and, judging from the number of inspection stamps, had been carefully inspected. It is apparent that the Russians had recognized the need for dependability of these parts and had made them with extreme care to provide that dependability. Pistons and bearings showed very little wear on either engine.

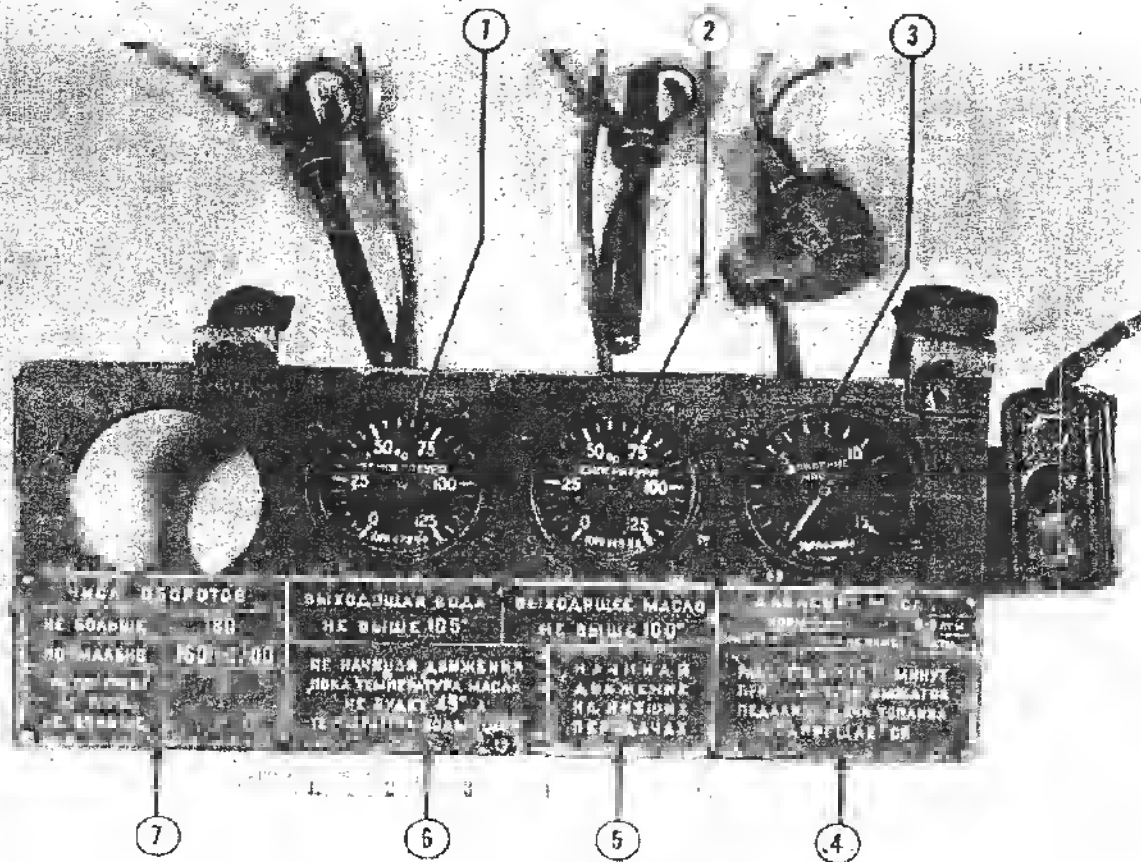
0106.6.5 - ENGINE INSTRUMENT PANEL

The fourth opening at the extreme left was unoccupied but had been intended for the engine tachometer, judging from the accompanying data on engine operating speeds. The tachometer, however, was found to be mounted on the same panel as the speedometer, just as had been noted in the Aberdeen report. It appears as though the tachometer may have been moved from the earlier location to the engine instrument panel, and then back to its original location in still later production.

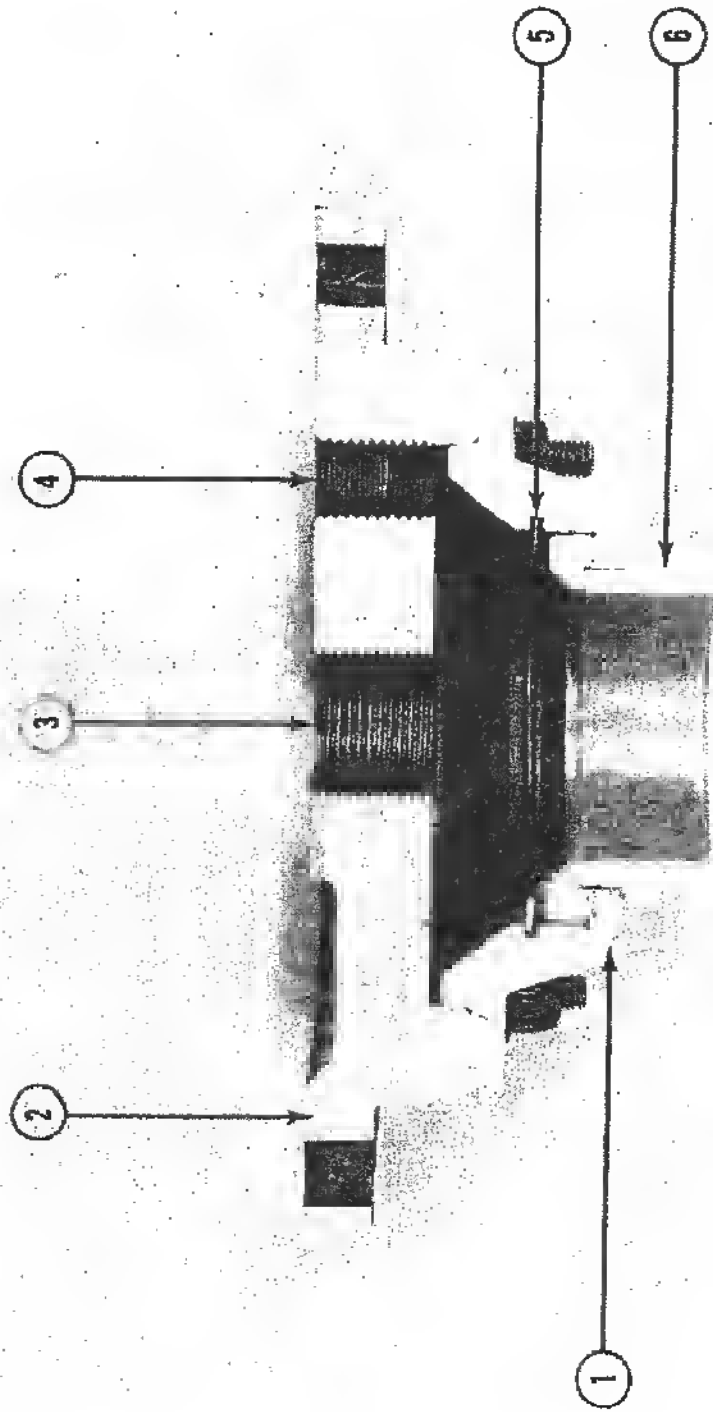
0106.6.3 c - OIL MANIFOLD, SECTION VIEW

Connection to the crankshaft was provided by a brass bushing having running fit with the end of the crankshaft and a flange that seated against the inside face of this oil manifold assembly. Apparently oil pressure was counted upon to push the bushing flange against the face of the housing to provide a seal. There was no spring to hold the bushing in place before oil pressure was developed. The bushing was allowed over .030 lateral movement to provide for imperfect alignment between the crankshaft and the oil manifold. The bushing was retained, however, with an internal expanding snap ring so that no more than .050 axial movement could occur. Apparently sufficient oil pressure was developed in this manifold even with the bushing away from its face seat to insure that the bushing would be pushed onto its seat.

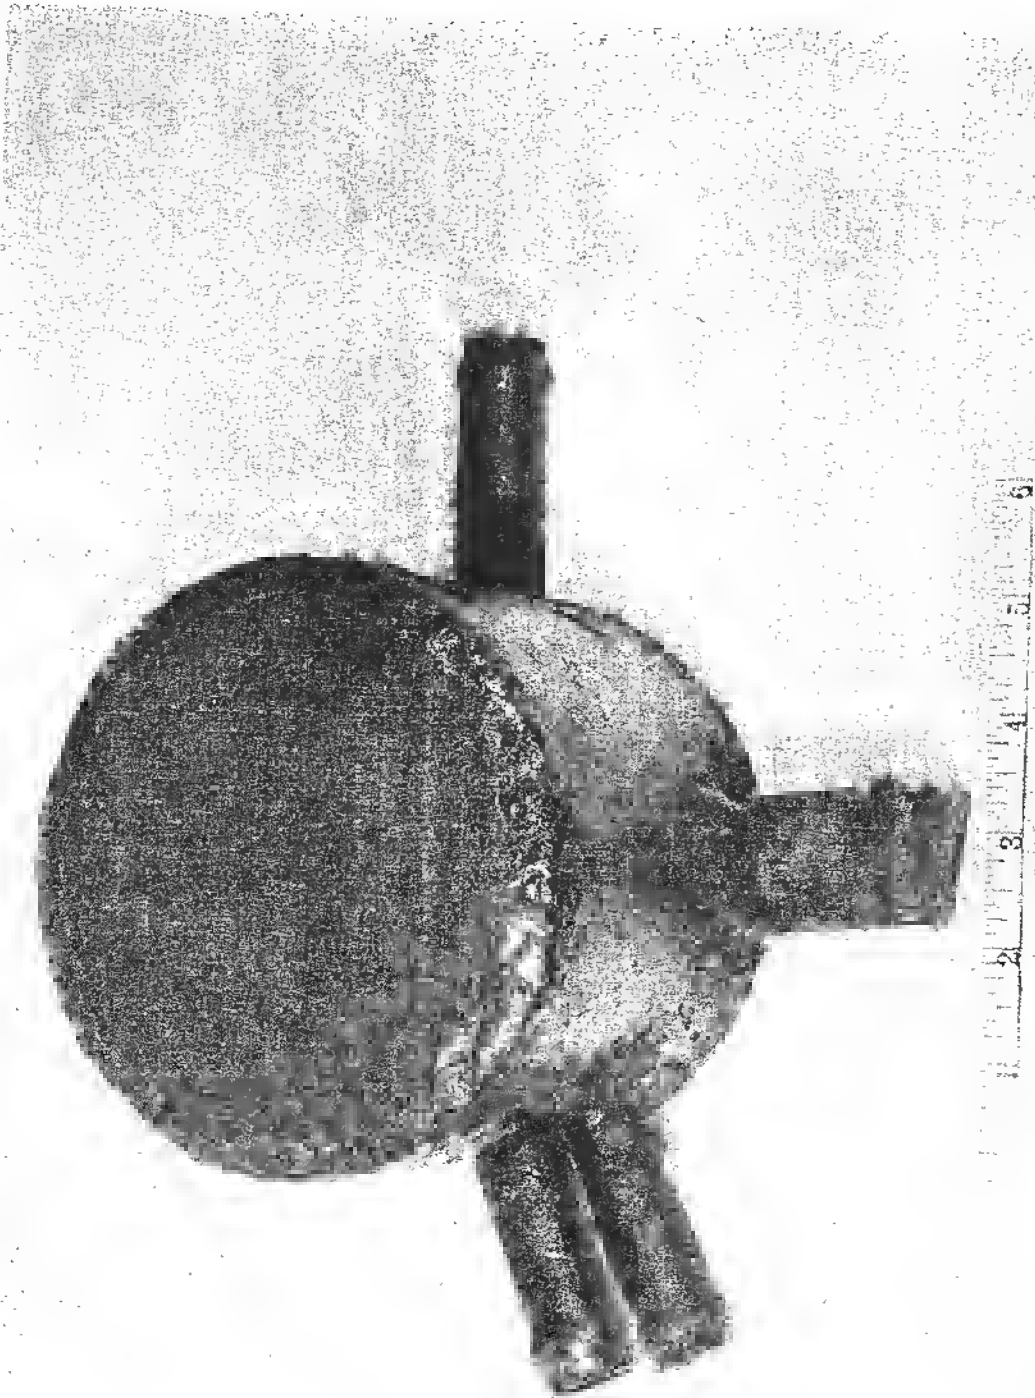
0106,7 a - HOLLOW CHAMBER IN LUBRICATING OIL LINE BETWEEN
RADIATOR AND OIL TANKS

The vessel was welded all over, with no means provided for access to the contents. One possible use of the chamber is to trap water vapor. The chamber was found in a high point in lines joining the oil radiator and the two oil storage tanks. Water vapor rising into the chamber would condense and drop to the bottom where, if it froze, no harm would be done. Later operation of the tank, with consequent rise of the oil temperature to and above the water boiling point, would automatically dispose of the entrapped water.

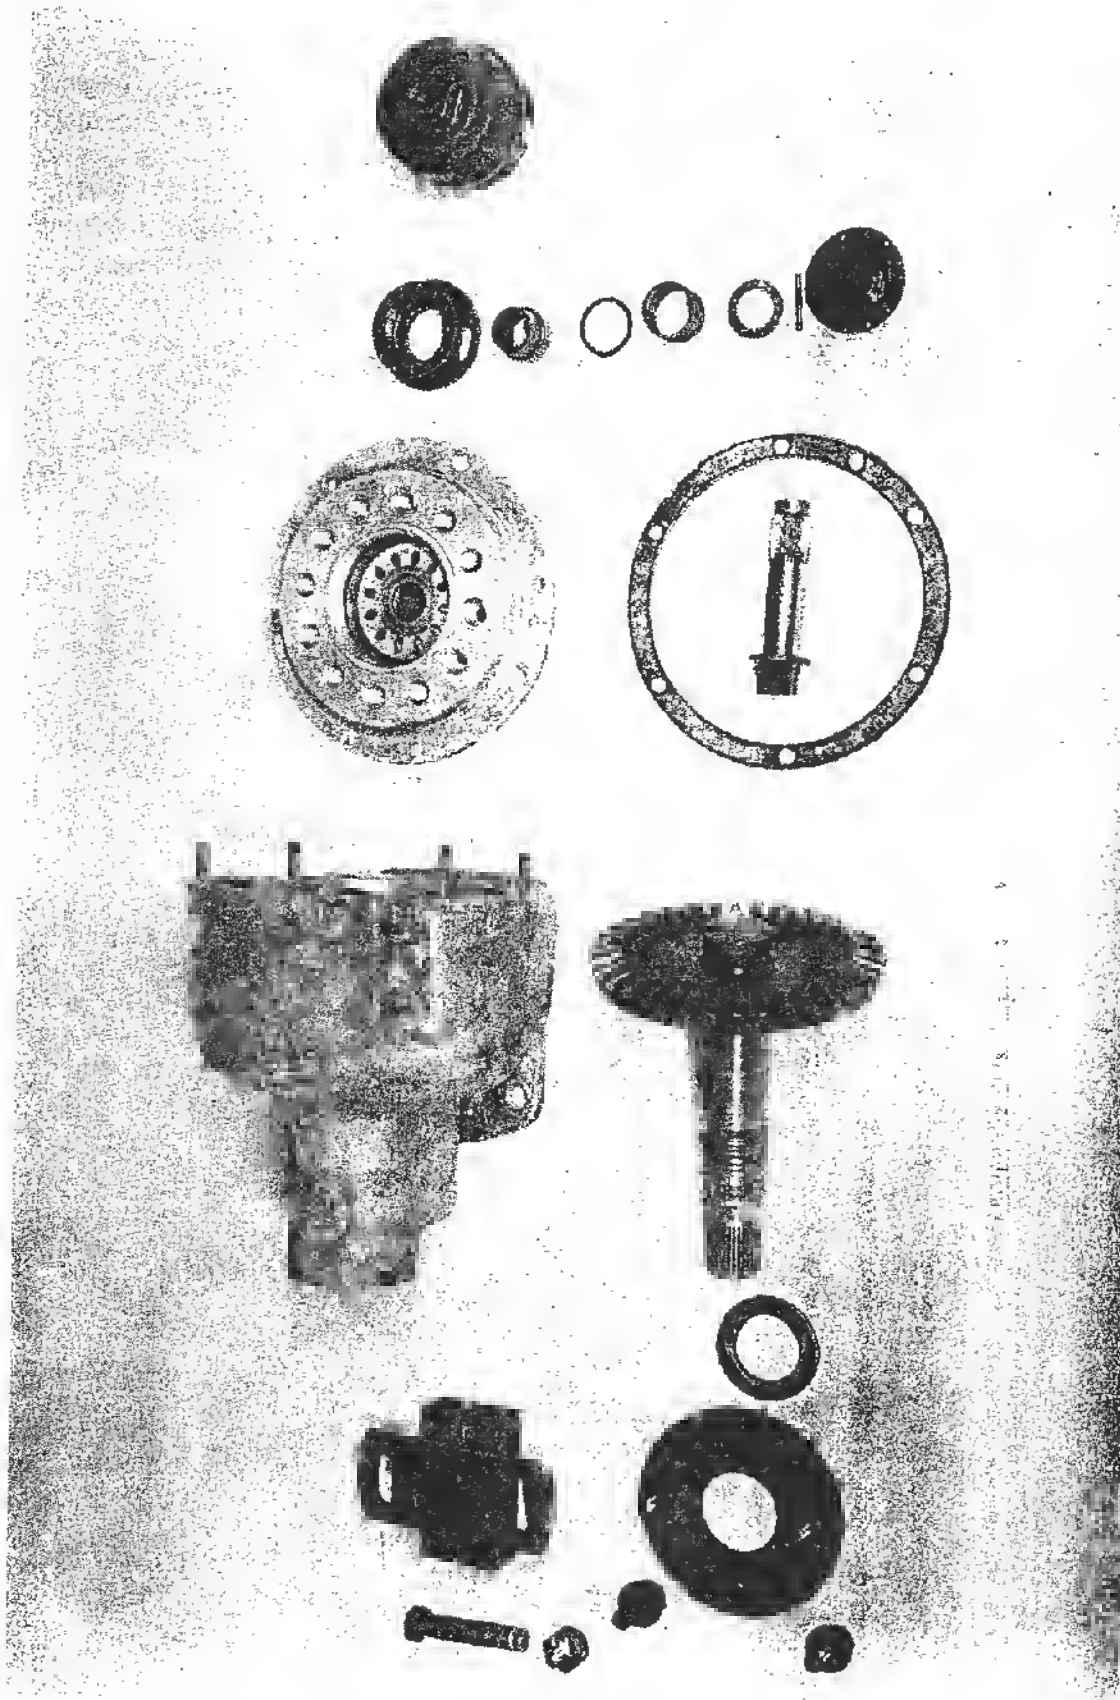
0107 c - AIR STARTER DISTRIBUTOR ASSEMBLY

The distributor housing and cover are aluminum alloy sand castings. The steel shaft at the output to the injection pump runs directly on the casting. The gears are shaper-cut. The internal and external splines serving to provide differential adjustment for timing were very well machined. The mating faces of the rotary valve parts were very smoothly ground. They showed virtually no wear.

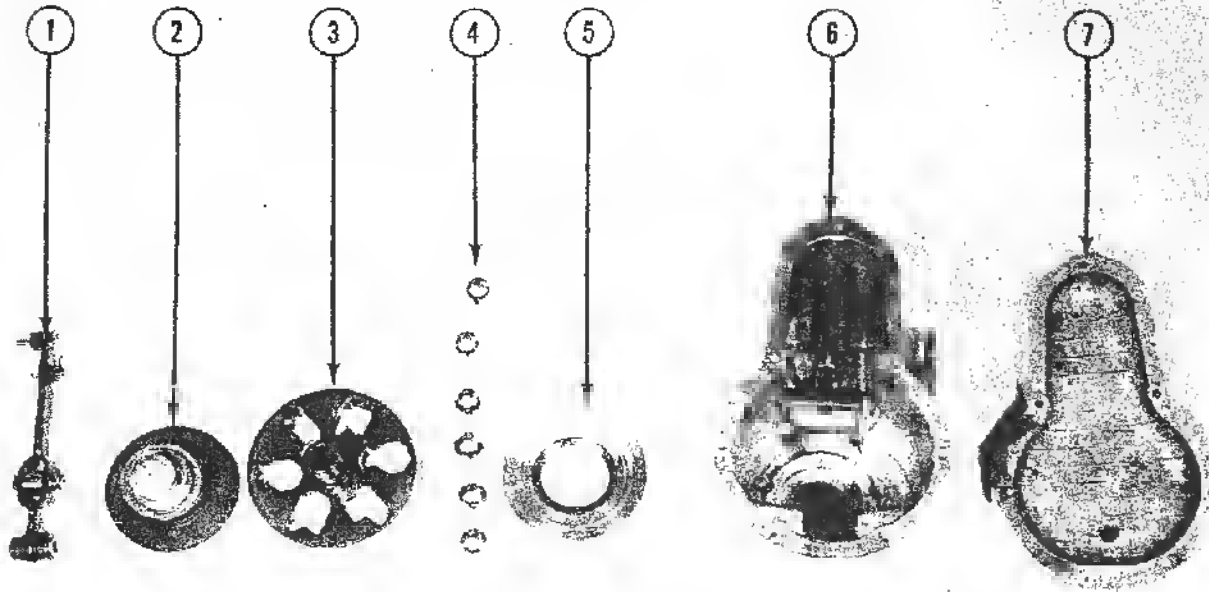
0308 - GOVERNOR ASSEMBLY - ENGINE

All interior parts were smoothly machined and in good condition. Wear on the pressure plates had occurred to a slight degree. A ball thrust bearing is used to transmit axial thrust and a needle bearing is used on the control arm. The governor case and cover plate were permanent mold aluminum alloy castings. [REDACTED]

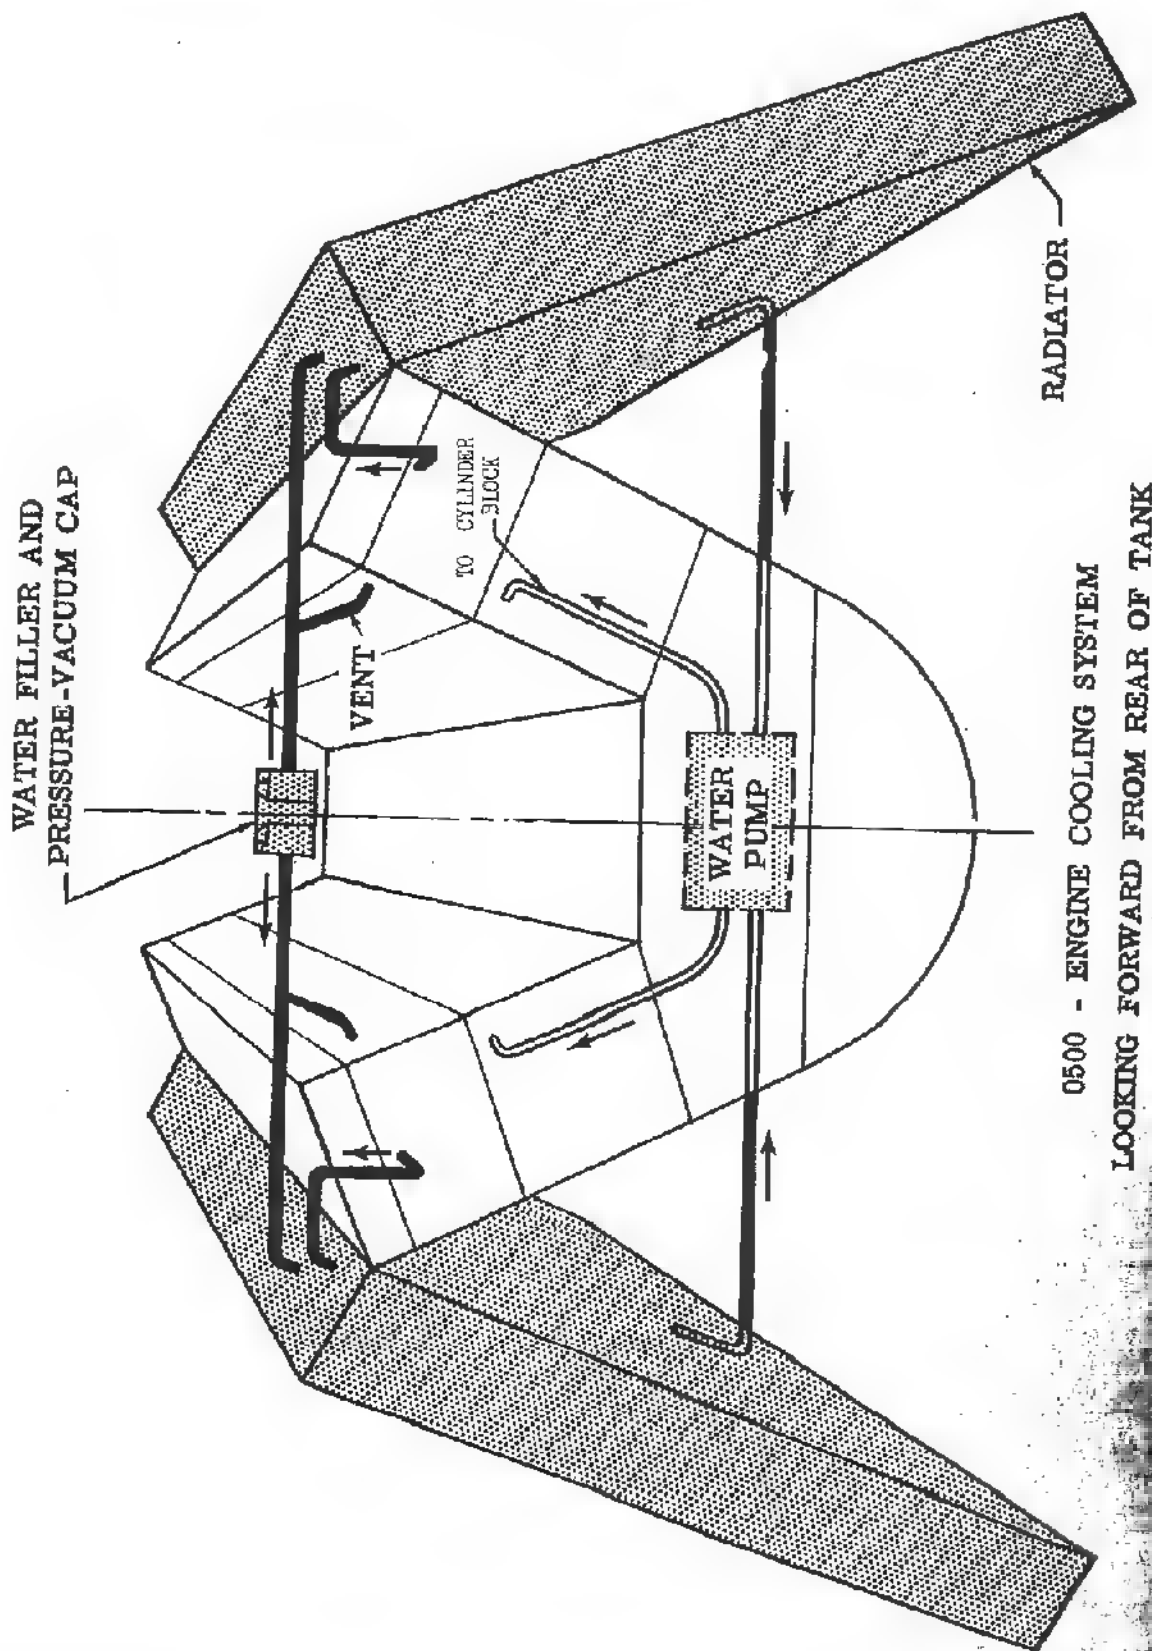
0500 - ENGINE COOLING SYSTEM
LOOKING FORWARD FROM REAR OF TANK

The G812 tank demonstrated some possible causes of the poor cooling in the Aberdeen tank. Tube and fin construction of the radiators was very poor, particularly the soldering of the fins to the tubes. It was estimated that over 90% of the fins were non-functional, either for heat dissipation or core support because of the poor contact area of fins to tubes. There was no oil radiator in the Aberdeen tank, as there was in the G812. The addition of the oil radiator would help solve the cooling problem and may represent a change in design for that purpose. There was no way to tell if a change in the size of the fan had been made since the Aberdeen report, but the fan in the G812 tank may be bigger than that described in the German report (dimensions in the German report are too vague to be sure of a change).

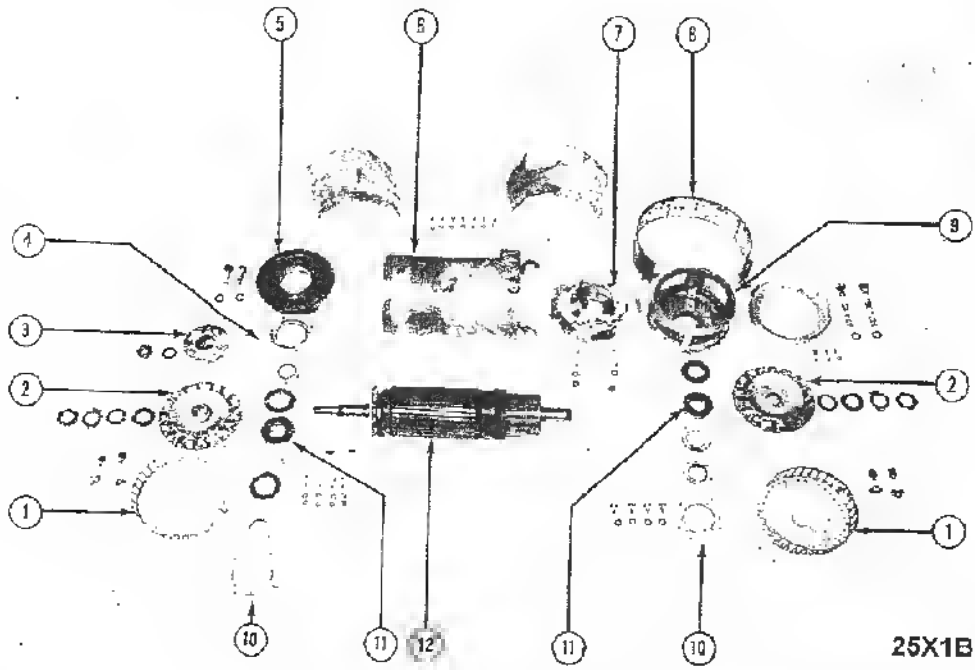
0601,1 b - GENERATOR - ENGINE

Both generators were found in excellent condition. The commutators, specifically, were smoothly finished and were unburned.

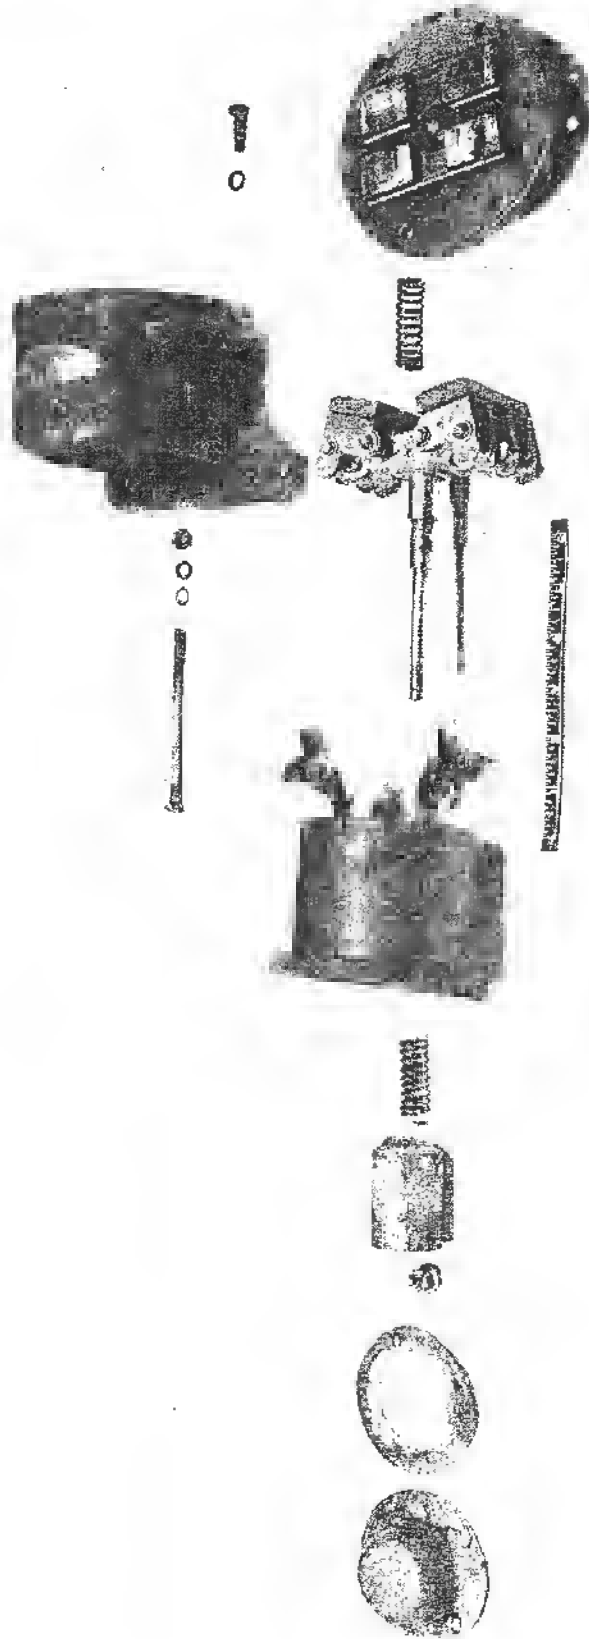
0603.2 a - STARTER RELAY

This relay appeared to be well made and seemed more than ample for its purpose. The contacts were unplated. Some burning had occurred, but the relay could still be expected to have an adequately long service life.

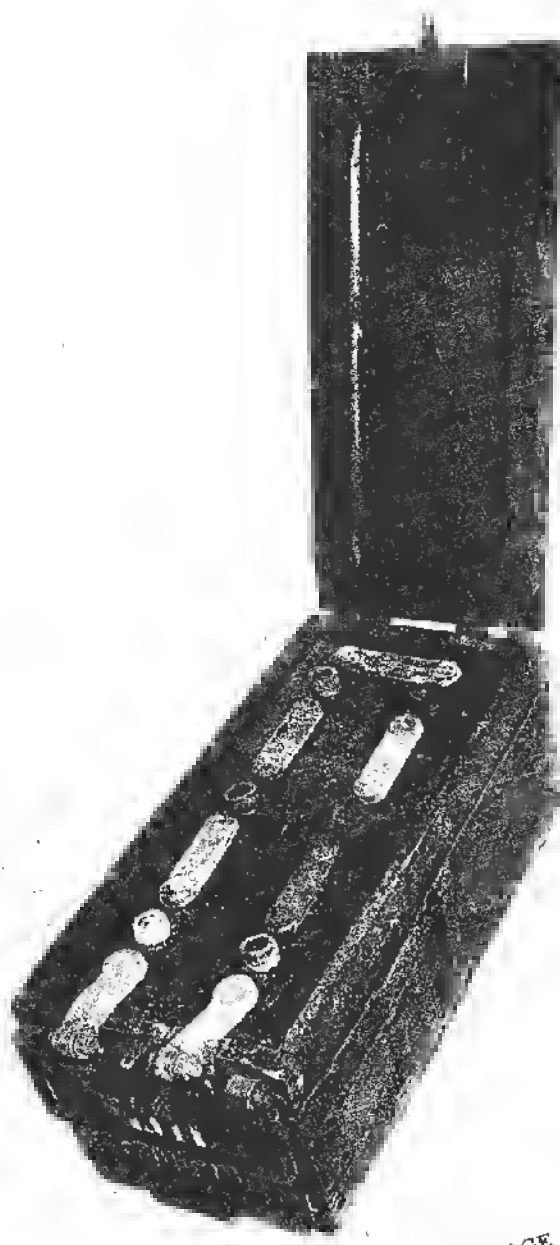
0612.0 b - STORAGE BATTERY

The batteries, as received, contained no electrolyte. The plates were found to be badly sulphated and warped. An attempt was made to return the batteries to a usable condition, but they were ruined beyond the point of recovery. One of the batteries was disassembled for inspection and the following data obtained:

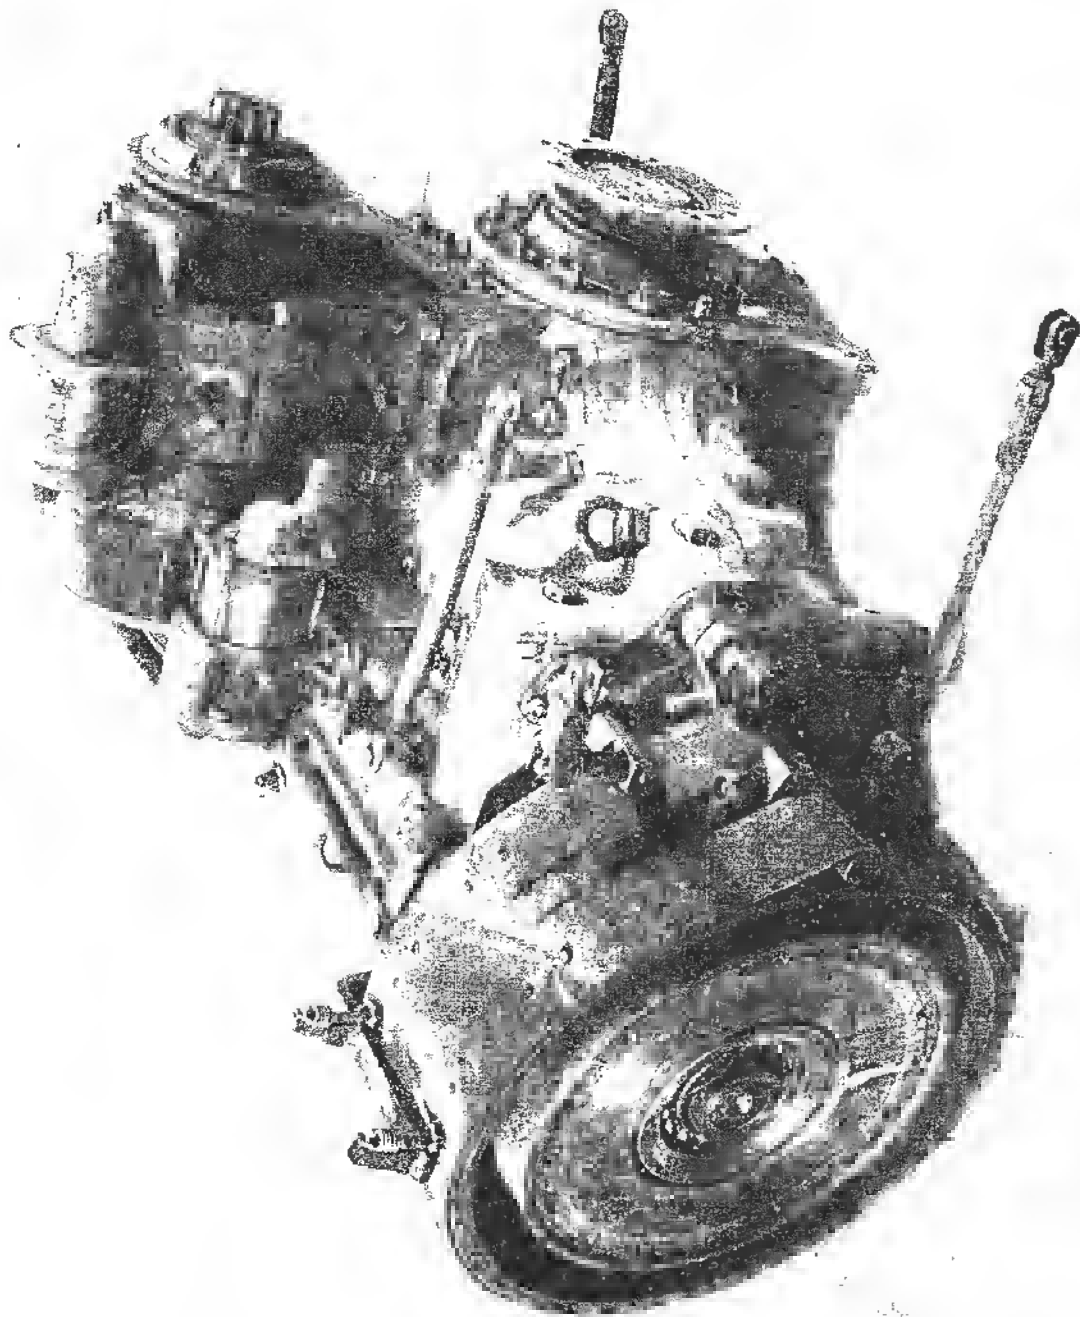
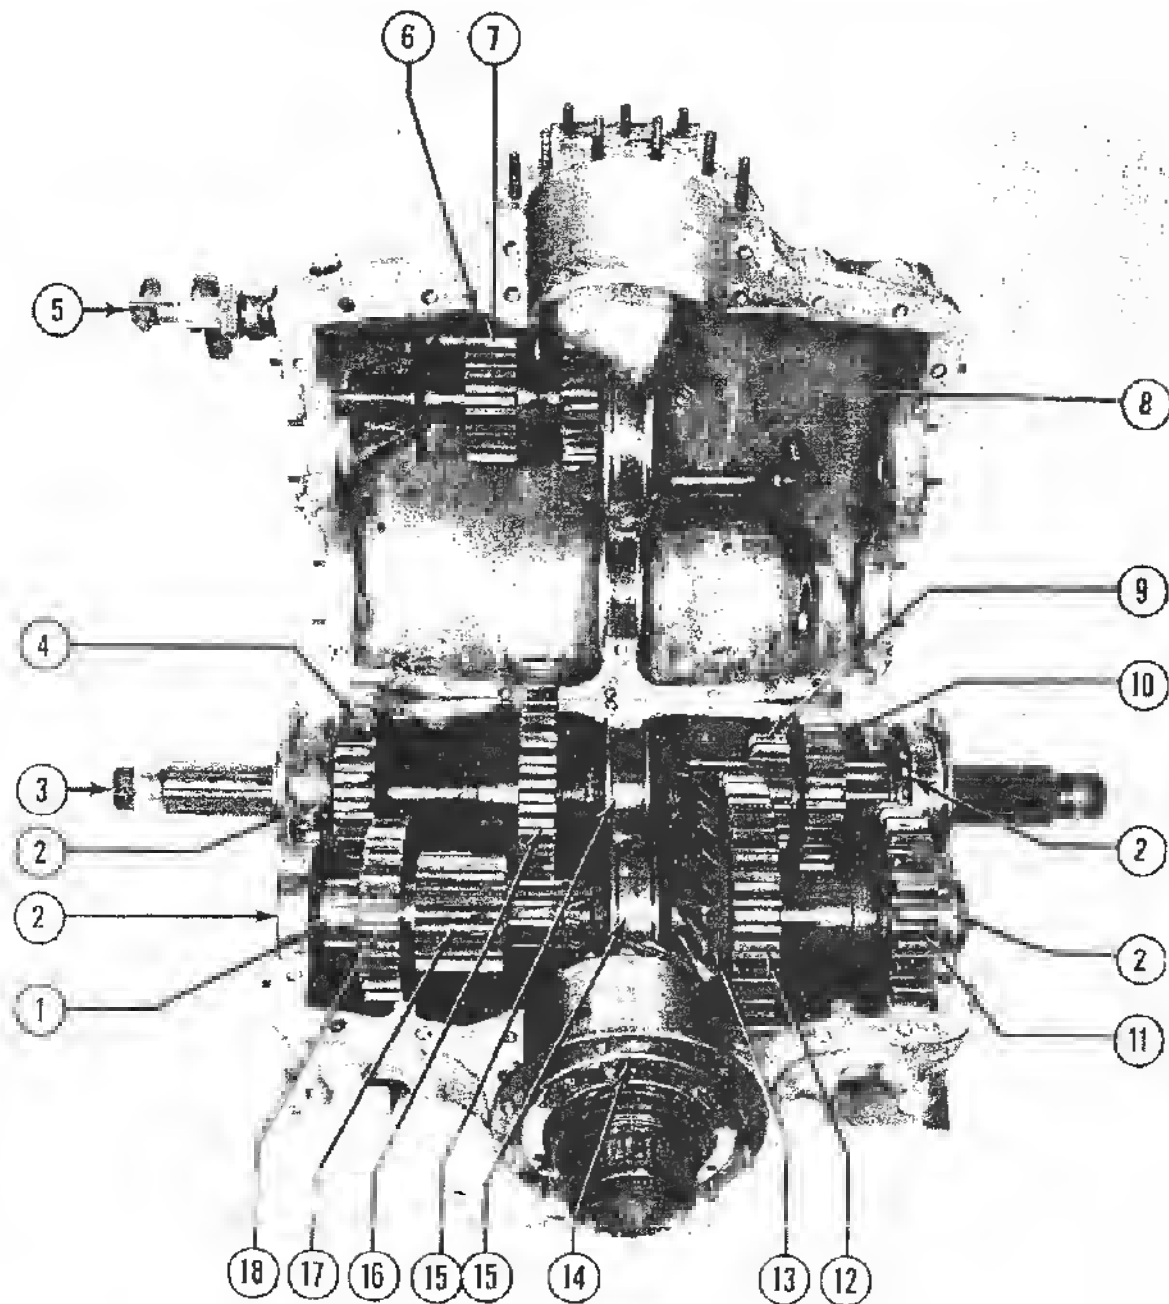
0700 f TRANSMISSION ASSEMBLY

Gear wear was found to have been so severe that the transmission was regarded as having failed. Photographs in Appendix I show the extent of damage, probably very largely the result of clash-shifting made especially severe at a standing start because of high clutch drag in the multi-disc dry clutch. The metal hattered from the gear teeth was found in the bottom of the case. Analysis of the half cup of solid material removed showed an all-steel content - no sand or aluminum casting fins, as was first suspected.

In addition to battering at the ends of the teeth, there was extreme wear across tooth faces. This may have been a secondary result of battering of the edges, but might have occurred anyway, - especially in view of a similar though less severe wear of the final drive gears. It was judged to be a lubrication failure, one that could certainly have been postponed through the use of extreme pressure type of lubricant. No E.P. additives were found when the transmission oil was analyzed.

The face wear on the gear teeth was found to be tapered across the gear, giving the teeth a twisted appearance. This wear pattern may have been the result of the bending and twisting of the shafts carrying the gears. Twisting of the shafts under torsional load could be expected to cock the splines and therefore the gears, and excessive and tapered gear wear could then result for two reasons:

The most extreme wear had occurred on the 1st and 2nd speed and reverse gears, where the clash shifting damage could be expected to be most severe. Complete failure appeared imminent. If the 1st speed gears became unusable, reverse would be lost as well. All the other ratios were independent, however, and the stripping of one set would not affect the others (except that steel fragments could jam in and hasten the destruction of the other gears). In any case, the transmission appeared to be a weak link in the T34 tank.

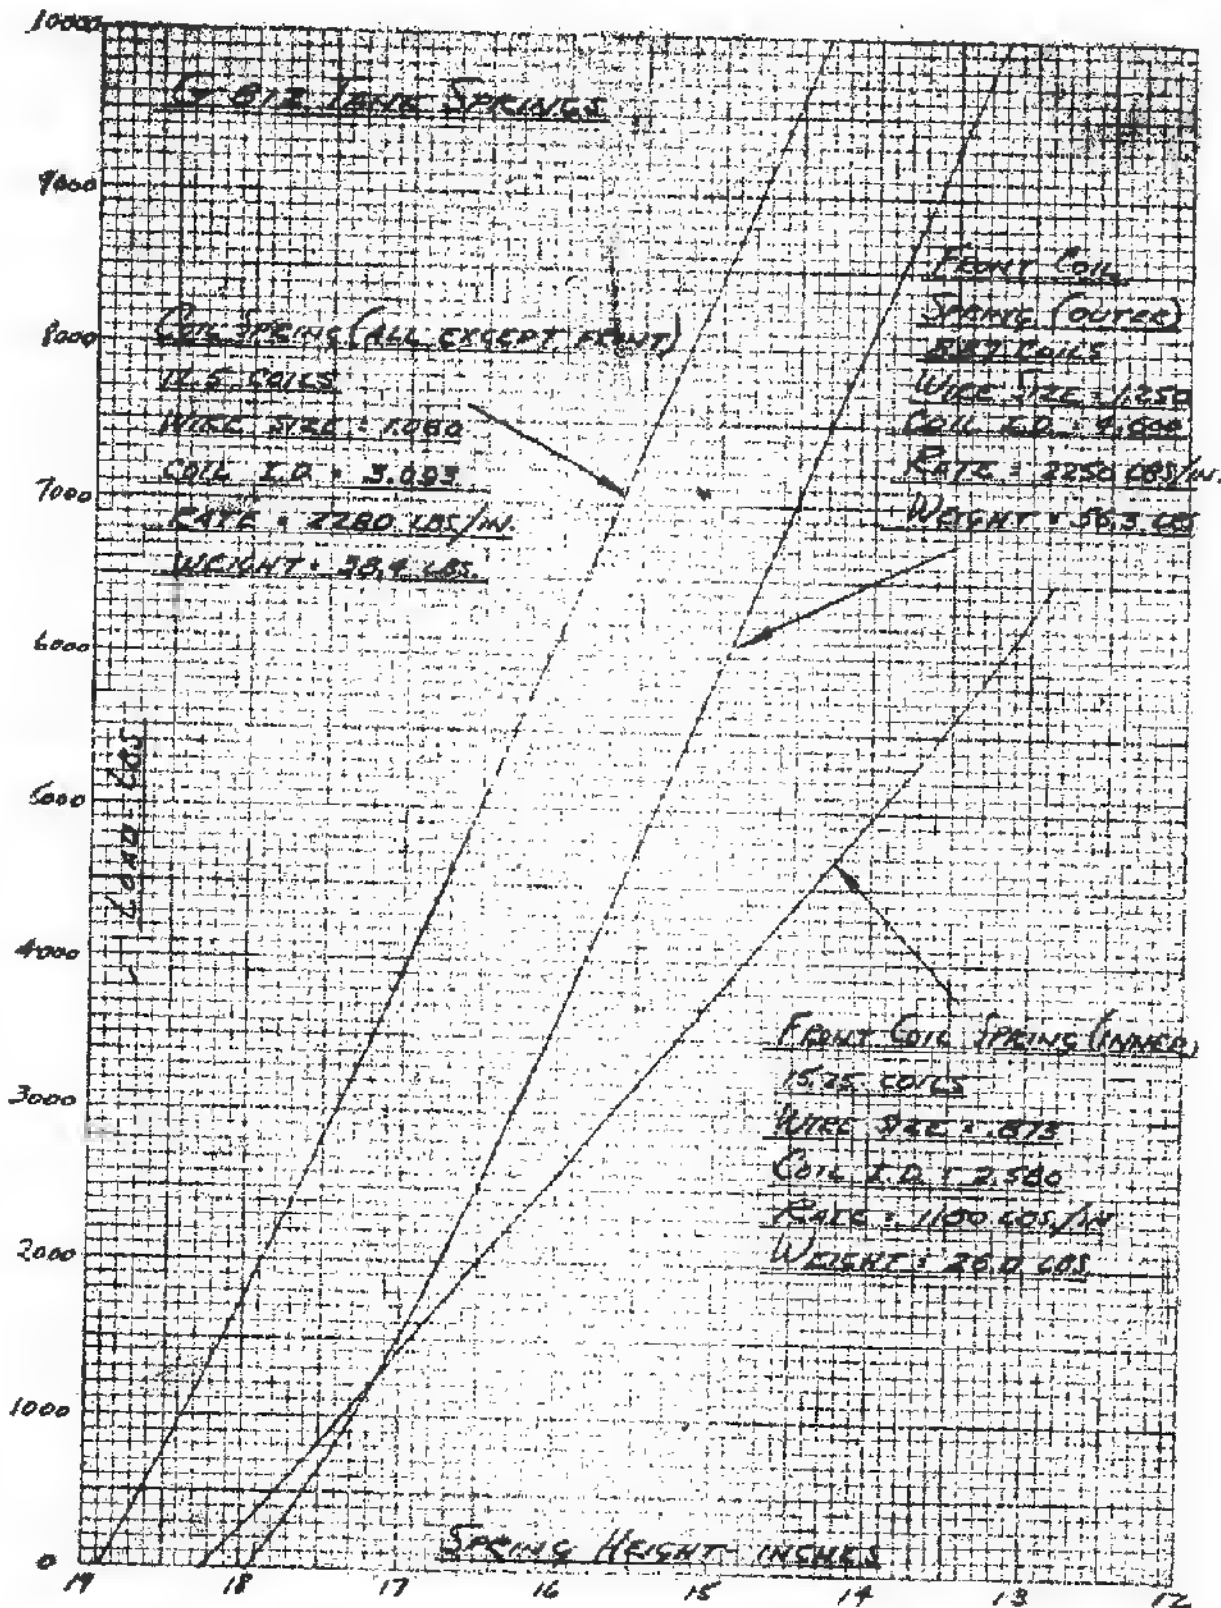
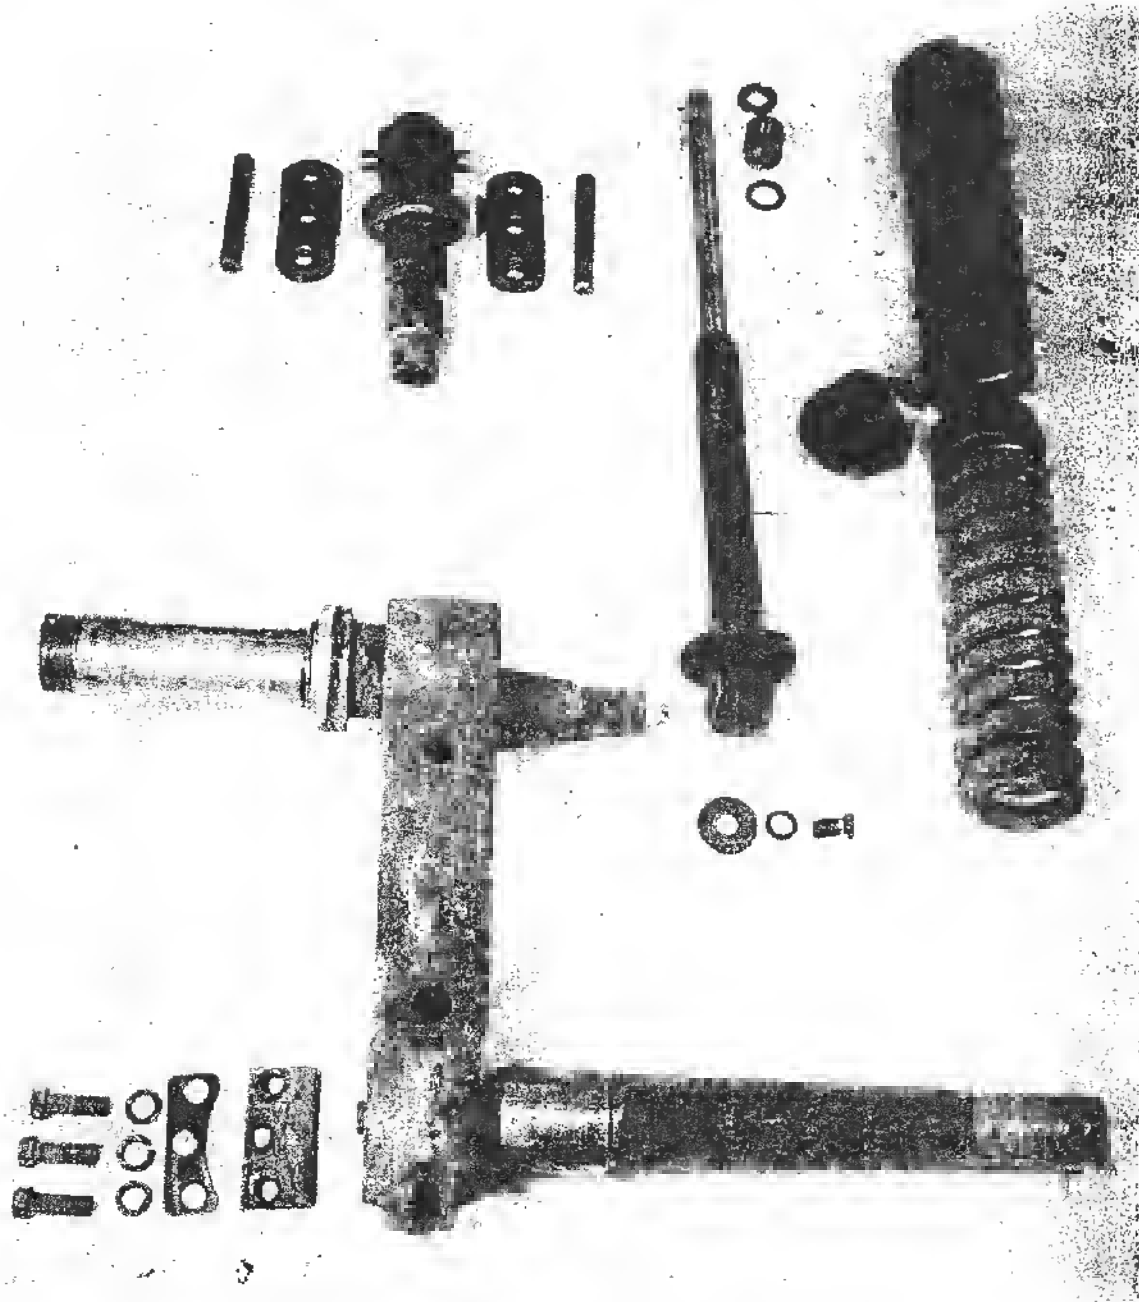
1800 f - HULL, CUT-AWAY VIEW SHOWING SUSPENSION

The two front suspension systems differed from the others in that the two coil springs were not in series but were concentrically arranged and were inside of the hull, rather than in housings which were welded to the hull. The coil springs were guided by a rod which was pinned to an arm splined to the suspension arm shaft. Clearances between the rod eye and the splined arm were not adequate, and bending of the guide rods accompanied by excessive wear had occurred.

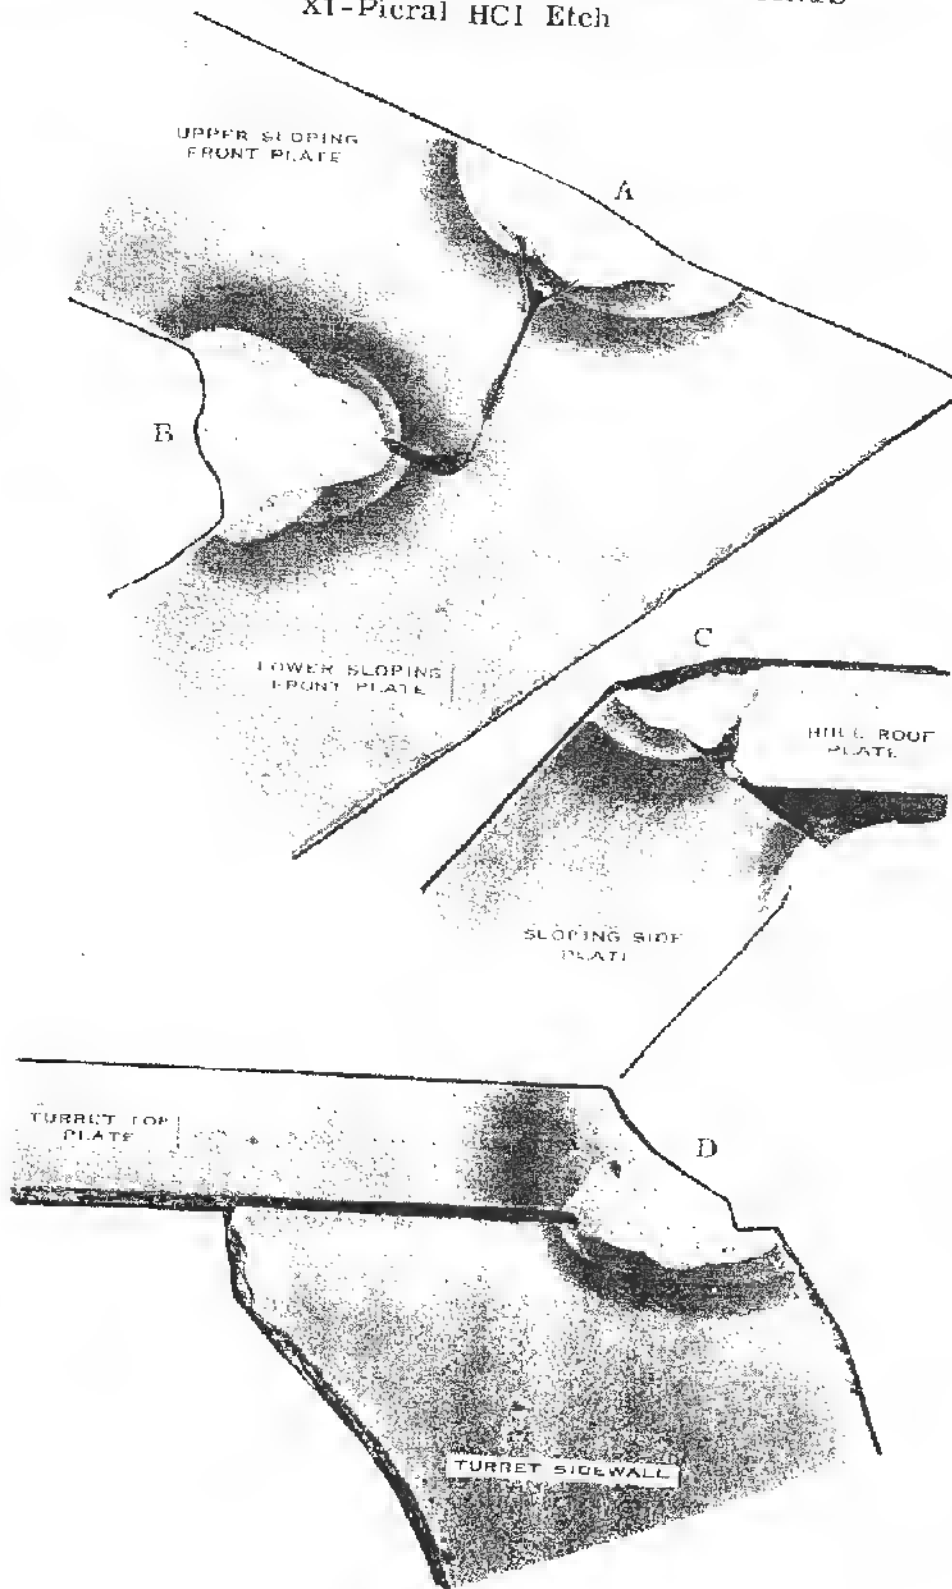
Figure 1

Figure 1. Bow joint between upper and lower sloping rolled homogeneous armor hull front plates, with the top plate resting in a groove cut into the lower plate. Outer and inner welds made with submerged arc process using ferritic electrodes.

Multi-pass weld composed of at least three beads. Top pass is automatic submerged arc. Underneath passes are also thought to be submerged arc as indicated by good penetration. Slag pockets present with intergranular cracking extending toward surface. Penetration and fusion is satisfactory as it was with other multipass welds. Hardness traverse across the weld interface showed variations in hardness from R"C" 18 in the weld metal, from R"C" 36 to R"C" 43 in the portion of heat affected zone that exceeded the critical, and from R"C" 30 to R"C" 44 in the area where the heat affected zone blends into the unaffected armor. No use was made of annealing bead technique.

Single pass weld made with manual arc process using stainless electrode. Very incomplete fusion. Fusion extends half way to bottom of groove.

Crack in weld metal result of wide shallow weld bead. Hardness readings in stainless weld vary from R"C" 6 to 18. The heat affected zone was R"C" 38 to R"C" 46 where it exceeded the critical temperature and R"C" 33 to R"C" 50 as this zone blends into the unaffected metal.
